# SANDRINGHAM BEACH AND GARDENS MASTERPLAN

Thompson Berrill Landscape Design P/L  
May 2017

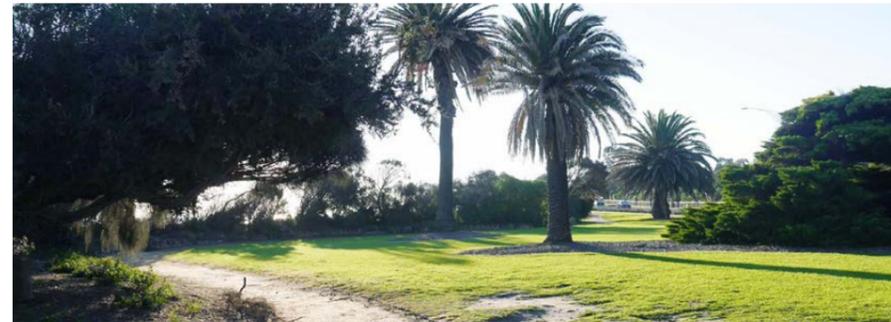
Photo 12: Sandringham Gardens grassed area

The formal lawns at Sandringham Gardens, shaped by the concrete edged symmetrical path network are an important part of the historic formal landscape character of the park. The gardens lawns were once irrigated however they have been degraded by a combination of drought, poor drainage and compaction from maintenance vehicles in many areas. Proposed works include:

**At Sandringham Gardens** regular ongoing pruning of the historic Cypress Trees is required to maintain clearance on the Bay Trail. In this area pedestrians typically use the various other unsealed path options through the gardens so there is less conflict with cyclists and the trees need to be carefully pruned to avoid die back. (O) Refer photo 12.

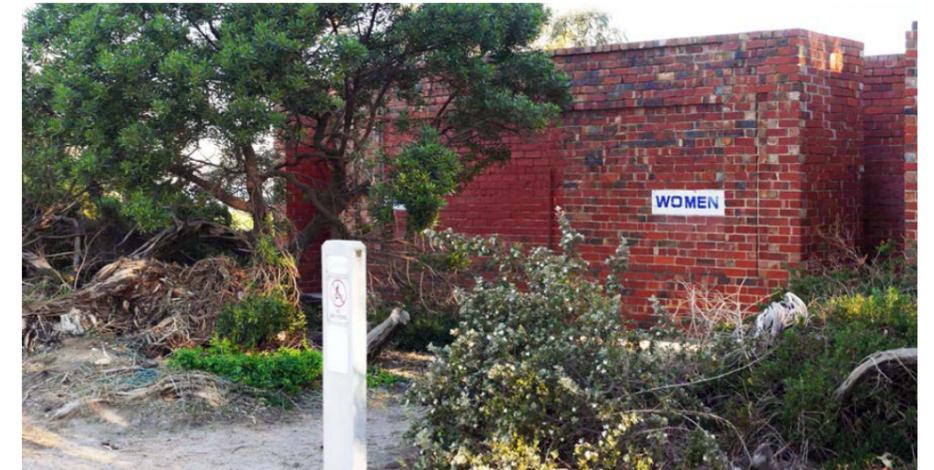
Photo 13: Southey Street Toilets

The older brick public toilet on the foreshore at Southey Street is to be replaced, the existing facility does not meet current accessibility standards and has been ranked within the top ten for major upgrade/replacement in 'The Bayside Public Toilet Strategy (2012)'. The existing red brick structure will be demolished and a new facility built that will provide a higher standard of compliance relating to safe design guidelines for public toilets, accessibility and the building code. The new facility will have safe designed cubicles, interiors that are bright, airy and hygienic, anti graffiti materials, accessible design and a compact footprint. One tree is proposed to be removed for sight lines to ensure those using the bay trail can enter and exit safely.

- Install signage within the B12 car park and at the pedestrian lights to alert visitors to the nearest public toilet at Southey Street. (H)
- Replace the Southey Street toilet to provide accessible cubicles within a contemporary facility at the same location. (H)
- Following upgrade establish a short sand coloured concrete path from the Bay Trail to the Southey Street toilets to improve all ability access. (H)
- Undertake weed control and revegetation around the existing SLSC toilet and beach shower using coastal indigenous species.(M)
- Continue ongoing management of vegetation to maintain clear sightlines for safety around all public toilet facilities. (O).

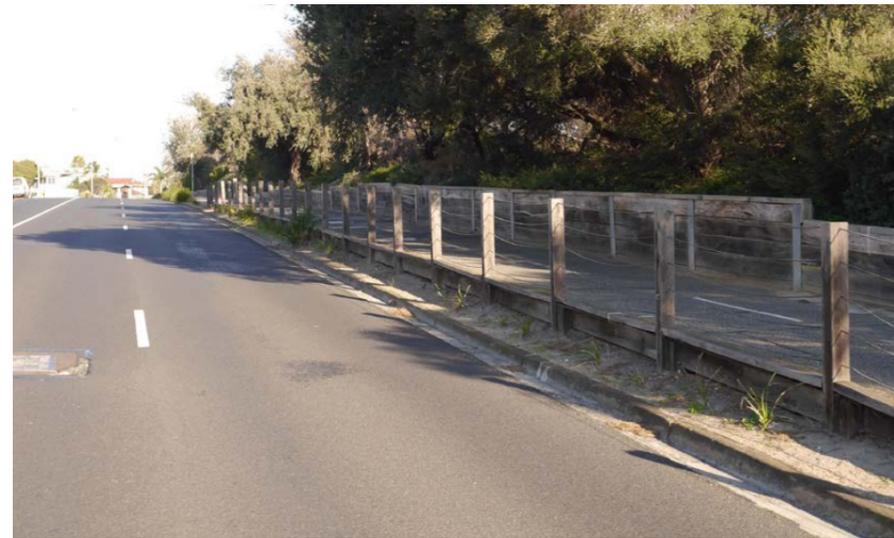
Photo 21: Bay Trail - Boardwalk at end of Red Bluff Street.

**Timber boardwalk and retaining wall section south of Red Bluff Street** section is only 2.5m wide and is used by both cyclists and as part of the Coast Walking Path as there is no alternative access. When replacement is required investigate options to widen the path to meet current standards while minimising impacts on vegetation. (M) Refer Photo 21.

- 5 Replace and widen the timber boardwalk and retaining wall section south of Red Bluff Street. (M)
- 6 Widen the path at the pedestrian crossing point at the traffic lights between Masefield Avenue and Royal Avenue. (L)
- 7 Investigate widening of the cantilevered boardwalk section of Harold Street and Edward Street. (L)

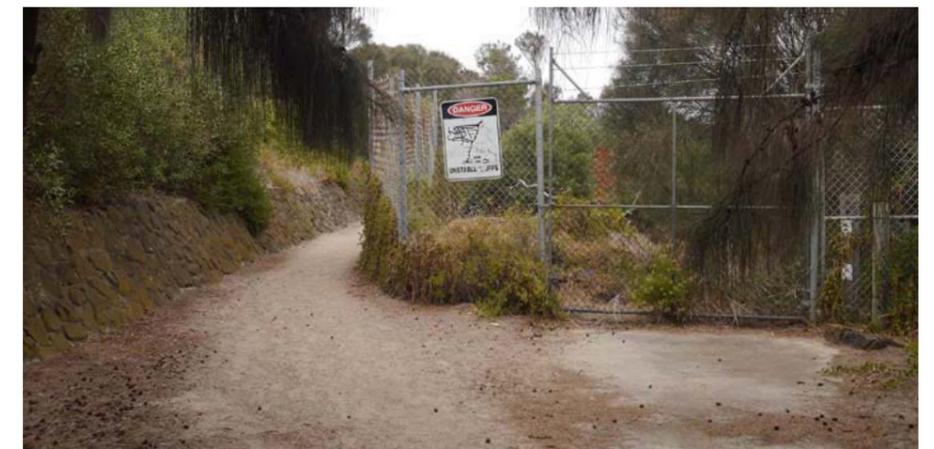
Photo 24: Existing fencing at Royal Avenue.

- Remove chain mesh construction fencing and replace with timber post and cable fencing to restrict access to the former beach access ramp. (H) refer photo 24.

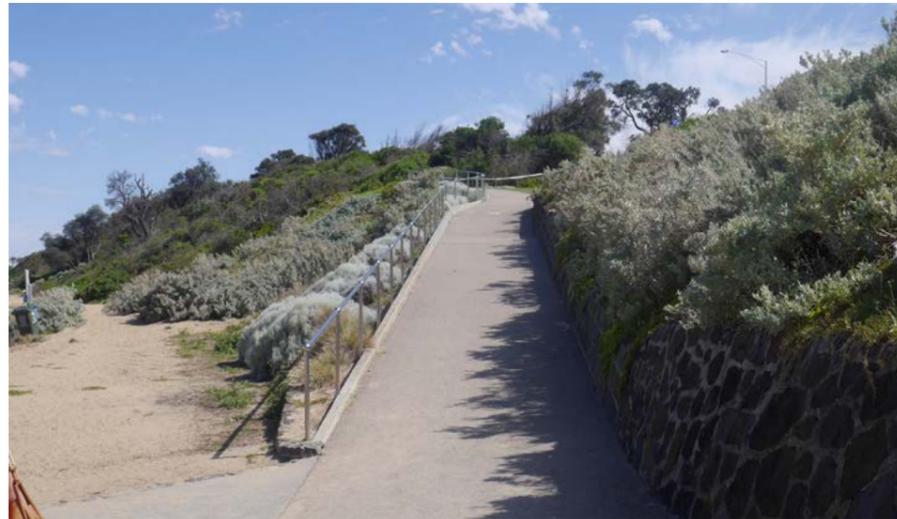
Photo 25: Sandringham Beach Access Ramp

This 2.5m wide asphalt ramp provides emergency and maintenance vehicle access to the beach north of the Sandringham Life Saving Club and is used by pedestrians visiting the public toilet and beach from the B10 Abbott Street car park. The ramp grade is approx 1 in 10, with flat landings every 15m and a stainless steel handrail to one side. It is proposed to establish stainless steel handrail to the other side and new bike parking at beach level. (H) Refer photo 25.

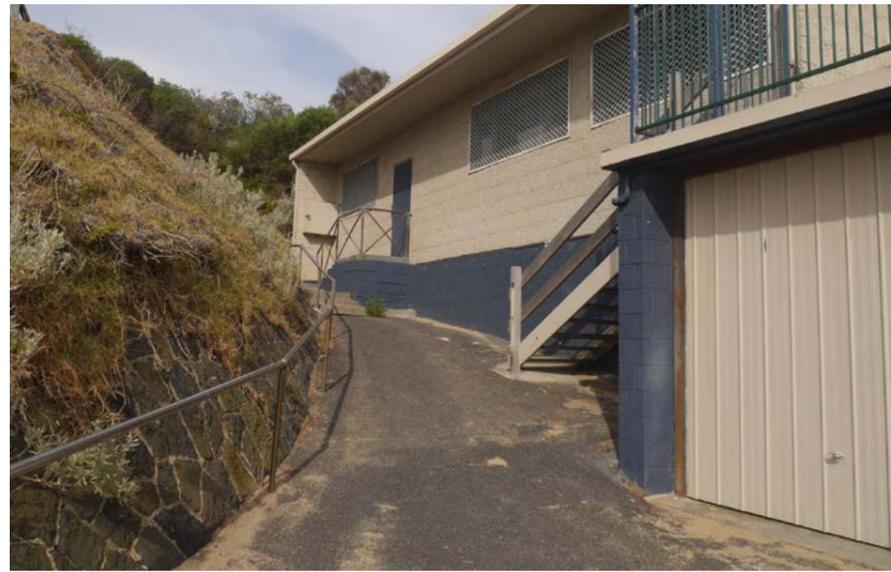
Photo 26: Sandringham Life Saving Club Stairs Ramp

This 1.8m wide asphalt ramp behind the building has short sections of bluestone stairs and handrail to one side. It provides the most direct access to the club for visitors parked on Beach Road and is sometimes used by club members at night. It is proposed to install a new stainless steel handrail and upgrade exterior lighting behind the SLSC. (M) Refer photo 26.

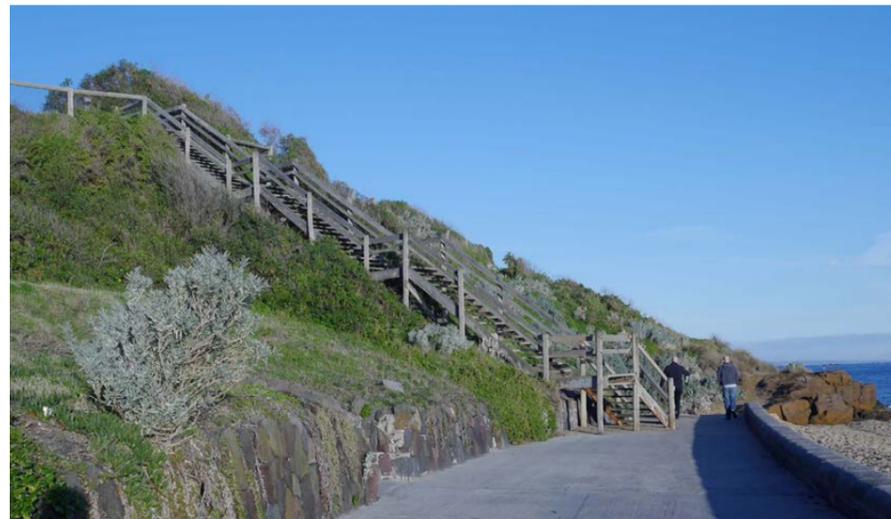
Photo 27: Bay Road Stairs

Established at the southern end of the sea wall path the stairs provide the most direct access to Sandringham Beach from the B11 car park, playground, picnic area and pedestrian crossing to the shops and railway station at Bay Road. The use of treated pine timber in this visually prominent location clashes with the predominant stone and concrete masonry character of the gardens. Despite ongoing maintenance the aging timber stairs will likely require complete replacement within 5 years. Refer photo 27.

- Consider replacing the existing timber stairs with a new set of stone/ concrete stairs set back into the bank to minimise visual impact, designed to match the existing character of the gardens. Subject to geotechnical investigation and impact on vegetation.
- Undertake revegetation of the former stairs site using low indigenous ground layer planting. (H) Refer Sandringham Gardens Detail Plan.

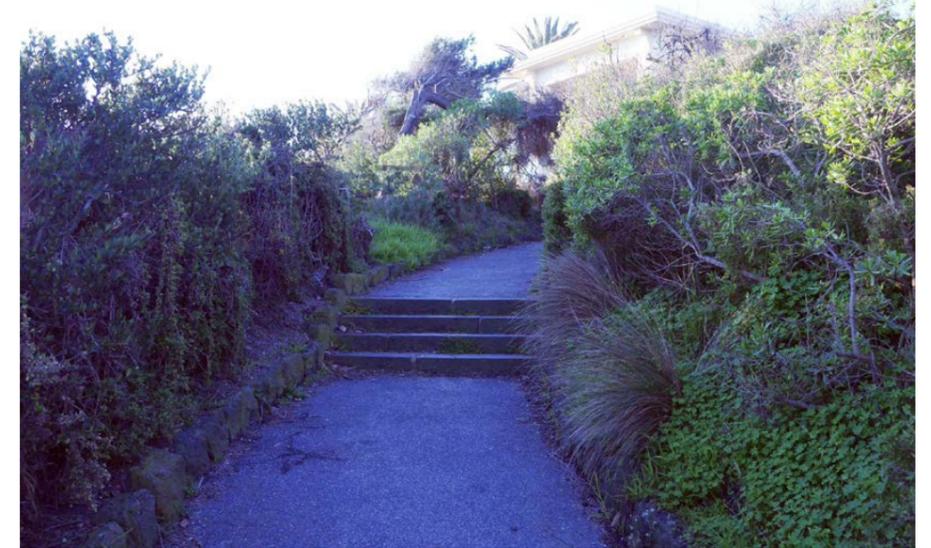
Photo 28: Rotunda Ramp

This 1.8m wide asphalt ramp has short sections of bluestone stairs and handrail to one side. The bluestone stairs link the rotunda down to the lower sea wall path. The ramp is typically used by visitors to the rotunda. It is proposed to install new stainless steel handrails to both sides. (L) Refer photo 28.

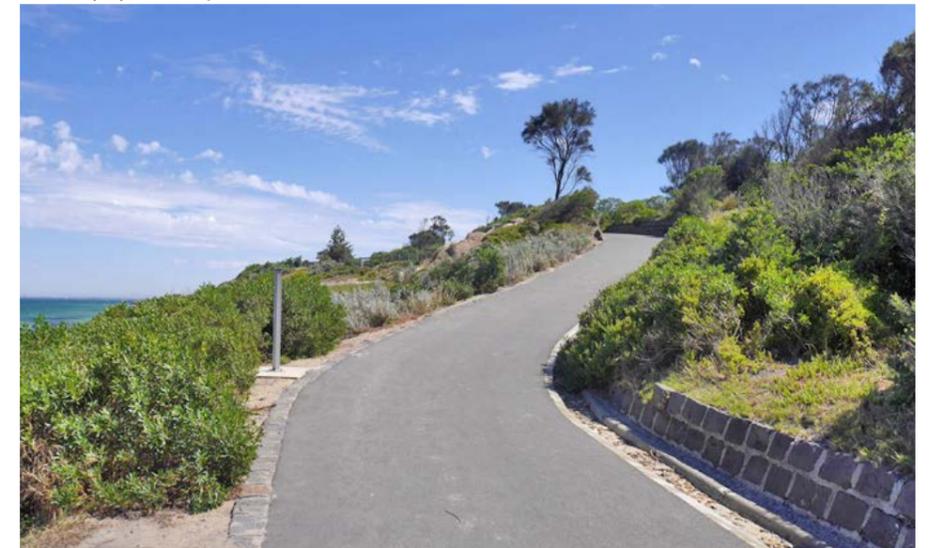
Photo 29: Sims Street Access Ramp

It is proposed to establish stainless steel handrails to AS1428 on both sides and investigate establishment of a beach shower and bike parking at beach level. (M) Refer photo 29.

2.3	9	Sims Street (B11 car park) beach access ramp. Establish stainless steel handrails to AS1428 on both sides.	220	lin.m	\$250	\$55,000	High	BCC	BCC	7.1

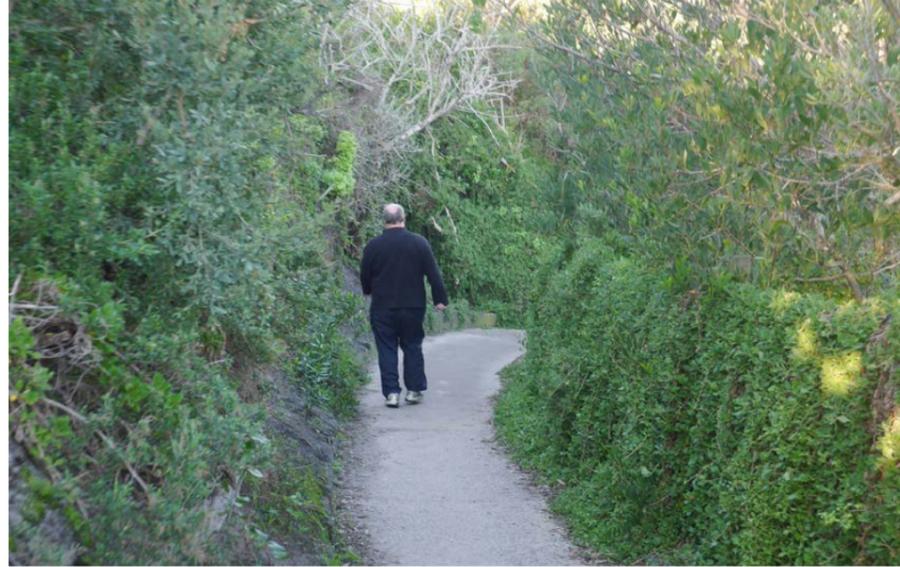
Photo 30: Coast Walking Path between Harold Street and Edward Street.

- Replace sections of log stairs using an all ability graded durable composite fibre mesh ramp backfilled with local granitic gravel/sand. (H)
- Establish a new handrail and advisory signage on the steep sealed path section between Harold Street and Edward Street. (M) Refer photo 30.

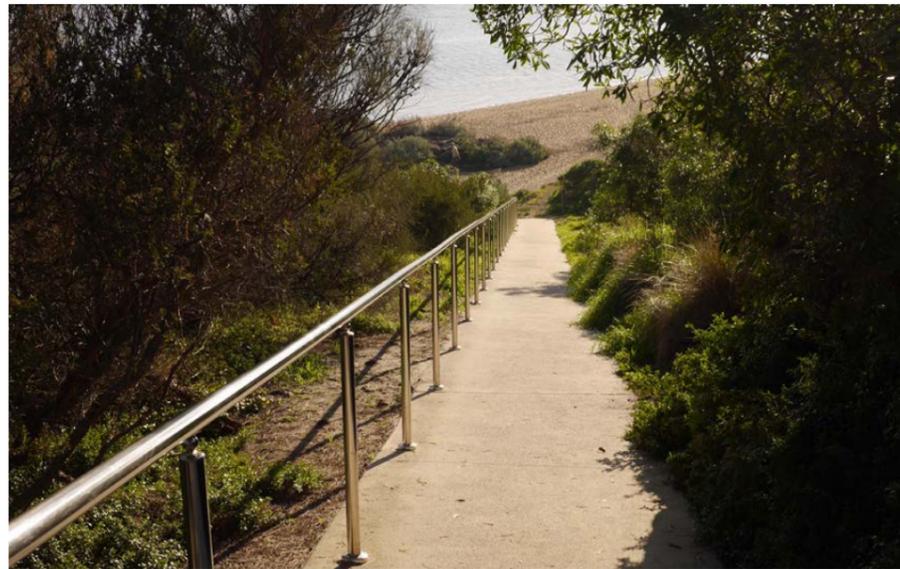
Photo 31: Southey Street Ramp

The steep concrete ramp was recently replaced after an older ramp, further south to Royal Avenue beach became unstable and was closed. The ramp is 1.5m wide with a handrail to one side. It is proposed to establish a handrail to the other side with a rest point and seat midway along the ramp and saw cuts in the concrete to increase grip. (L) Refer photo 31.

2.6	10	Southey Street access ramp. Widen the path to min1.5m, establish flat resting spots and install stainless steel handrails to AS14285 on both sides with additional saw cuts to the concrete to improve grip.	1	Item		\$70,000	High	BCC	BCC

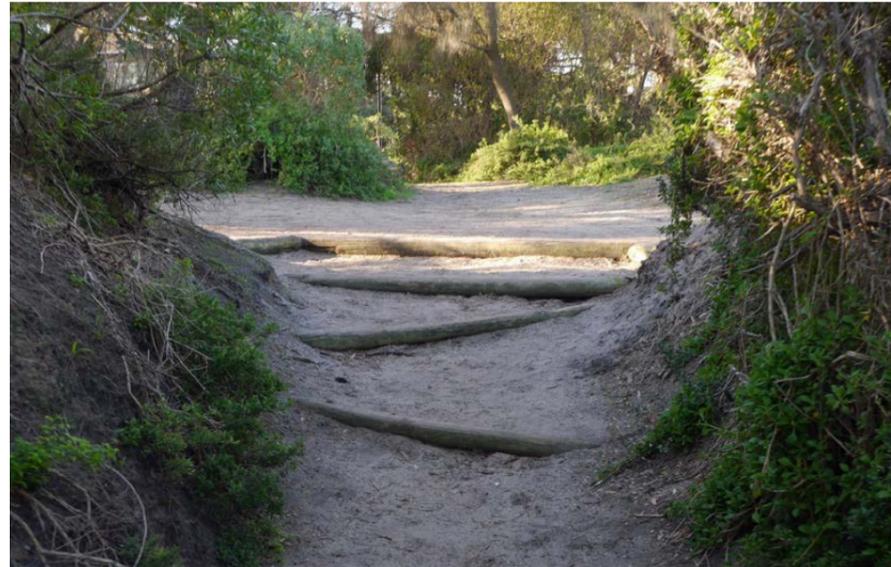
Photo 32: Top of Royal Avenue Stairs.

It is proposed to remove the timber log steps and upgrade the unsealed path from Beach Road to the top of the stairs and replace the drinking fountain. (M) Refer photo 32.

- 11 Royal Avenue Stairs - Remove the timber log steps and upgrade the unsealed path from Beach Road to the top of the stairs and replace the drinking fountain. (H)

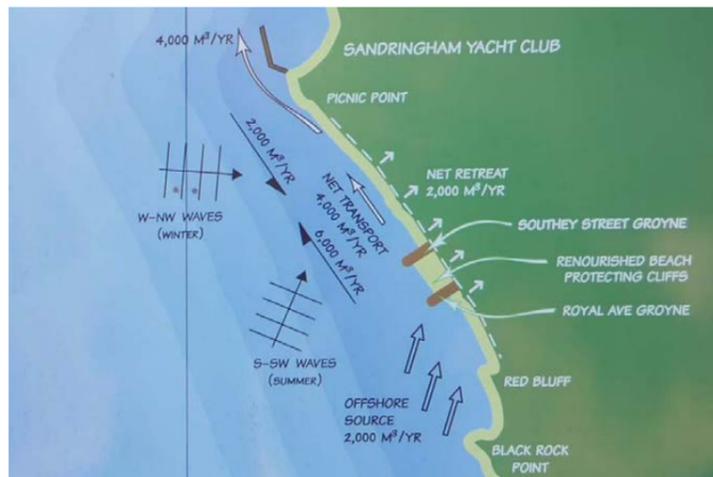
Figure 4. Coastal process at Sandringham Beach (DELWP)

The Royal Avenue and Southey Street beaches have been subject to ongoing erosion, especially over summer. Two rock groynes were established to improve retention of sand on the beach and to protect the Royal Avenue cliffs and infrastructure behind them. Despite this, some sections have been subject to ongoing erosion and storm bite. The Department of Environment Land Water and Planning (DELWP) is responsible for works and ongoing monitoring of the beaches. DELWP are currently investigating modifications for Southey Street and Royal Avenue groynes and renourishment of the existing beach in between. The Sandringham Foreshore Association also provide local input and assistance with monitoring of coastal conditions and erosion.

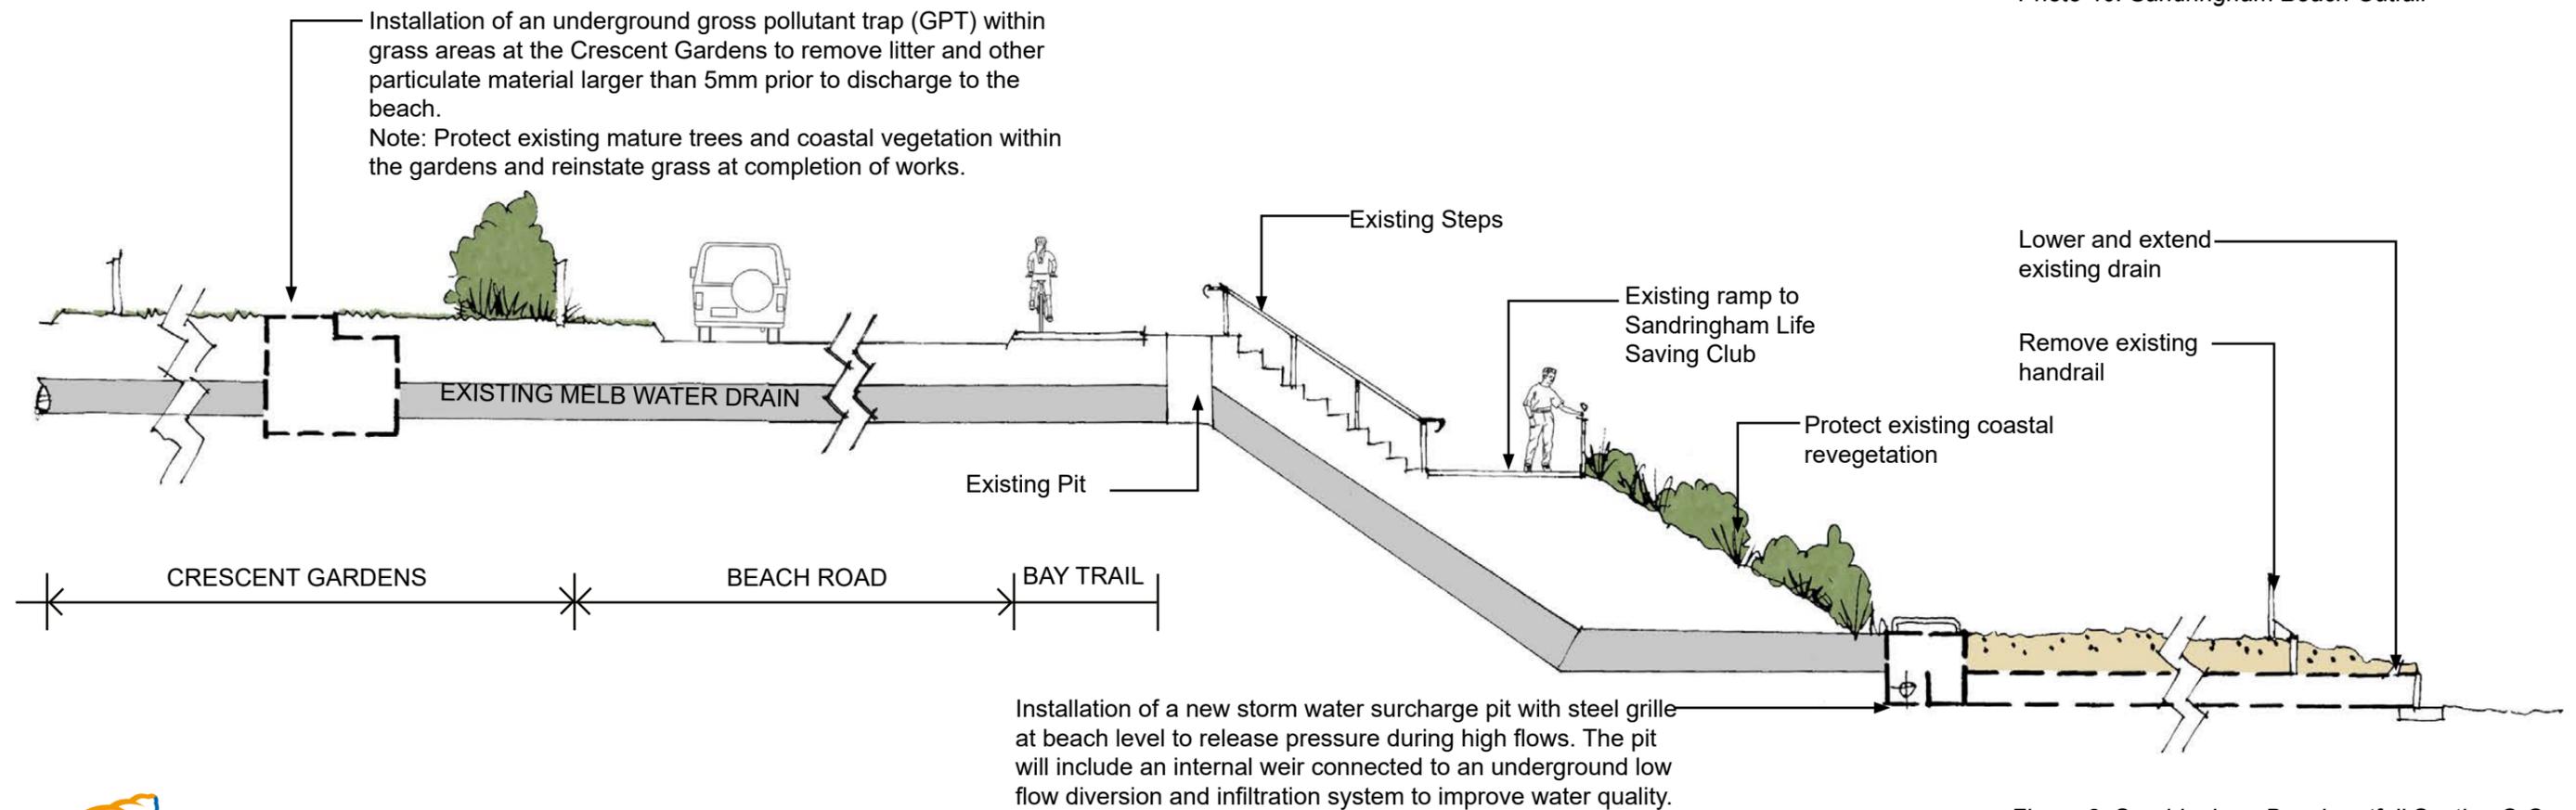
Figure 8. Sandringham Beach outfall Section C-C

# SANDRINGHAM BEACH OUTFALL SECTION C - C

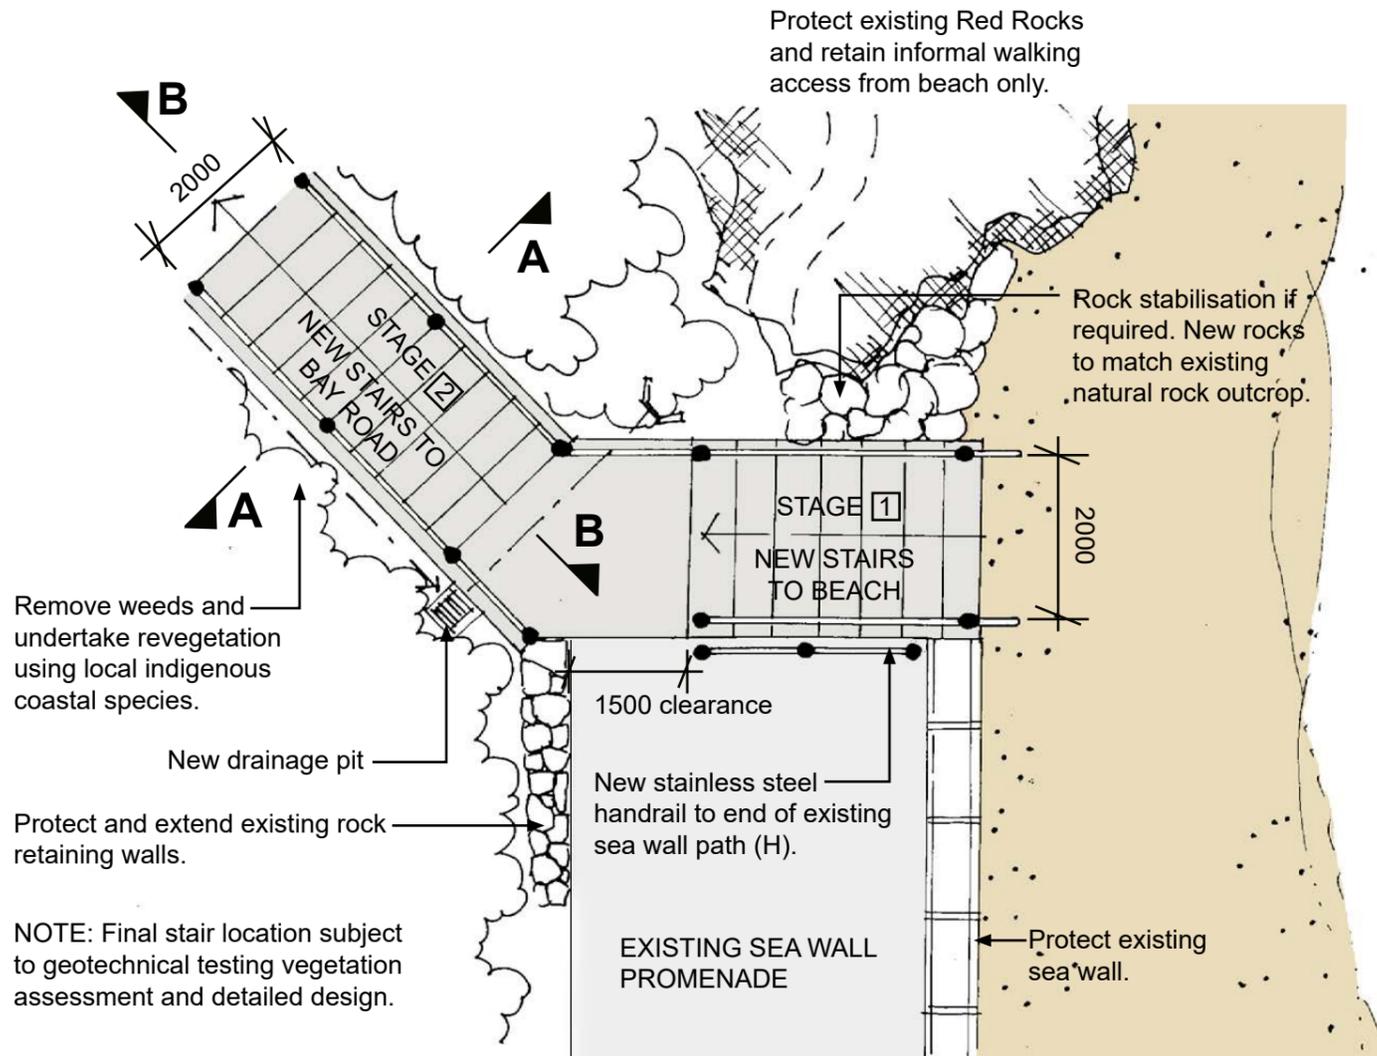
Figure 9. New Bay Road Stairs Detail Plan

# BAY ROAD STAIRS REPLACEMENT DETAIL PLAN

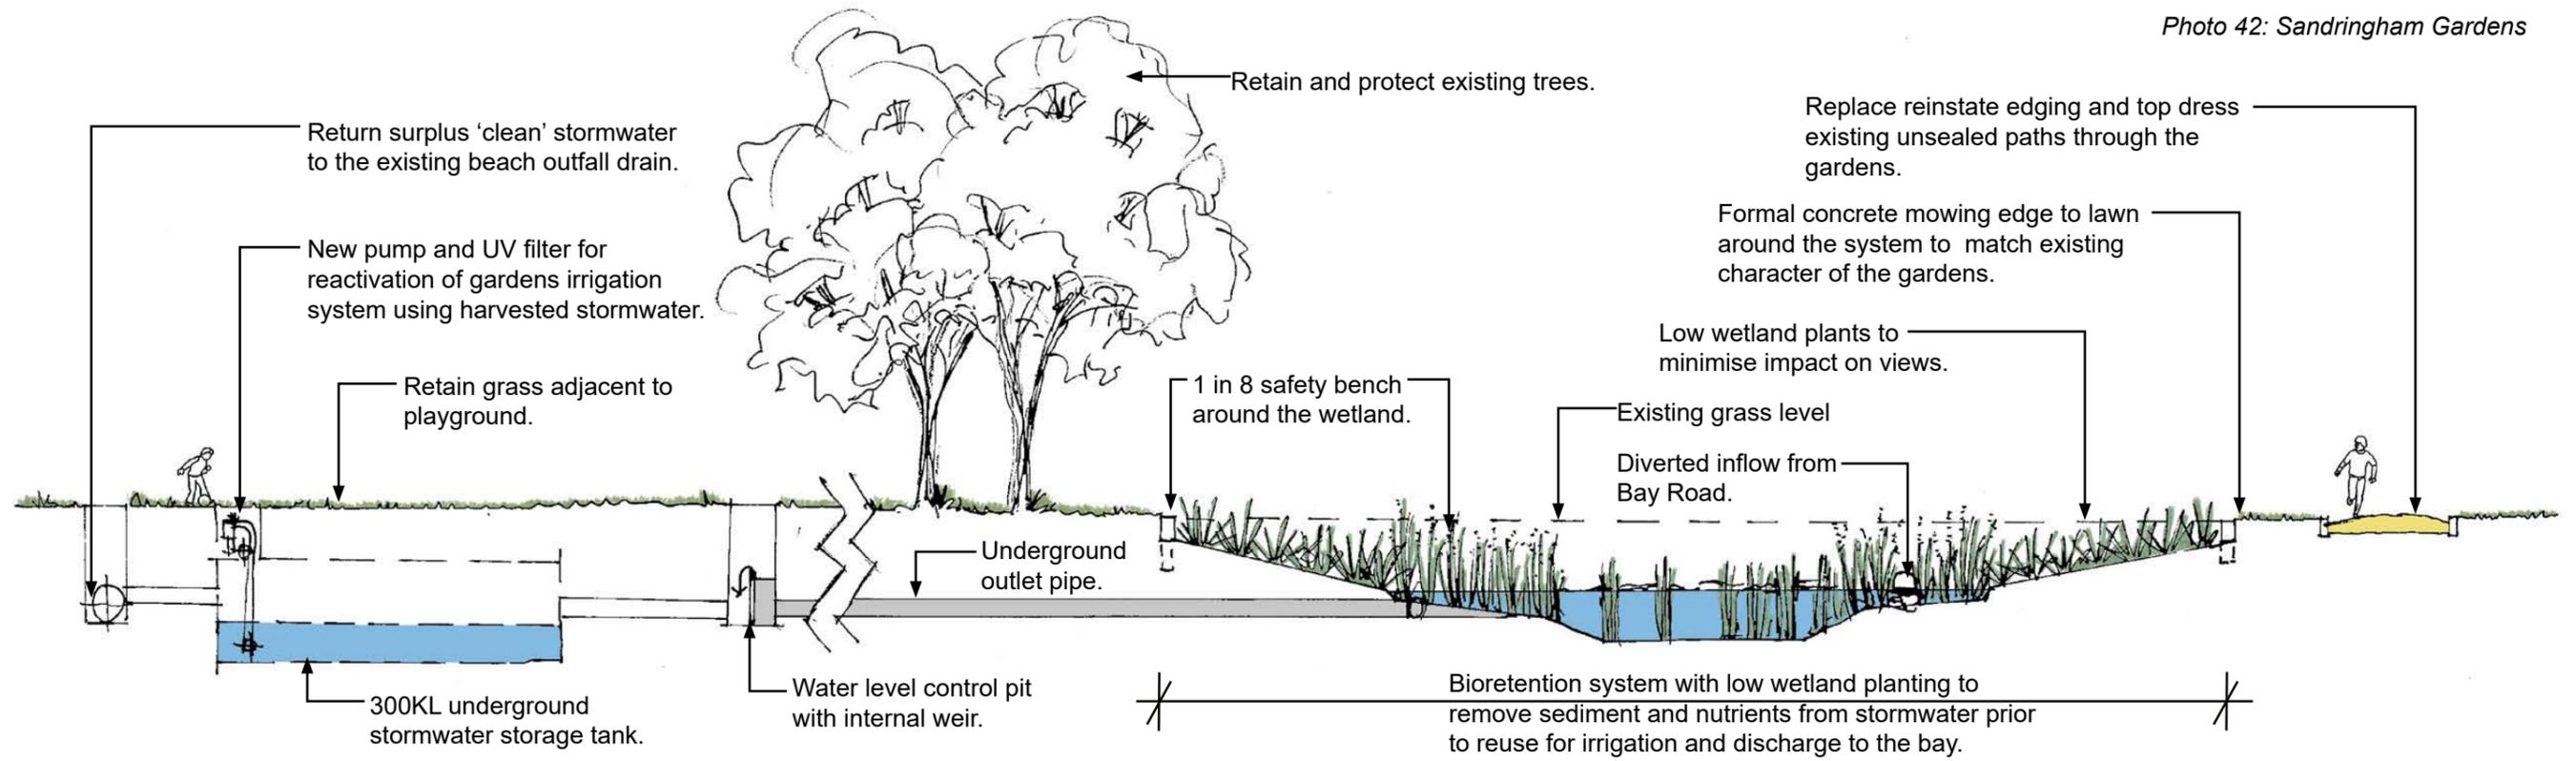
Figure 14 Sandringham Gardens Bioretention system

# SANDRINGHAM GARDENS WETLAND TREATMENT SECTION D-D

- Excess storm water, not needed for irrigation, will be returned to the existing pipe outfalls.
- Investigate upgrade to existing storm water outfalls at Red Rock below the playground. (M)
